### • Resolve unusual engine vibration and noise

Prevent catastrophic engine failure with a Fairbanks Morse analysis

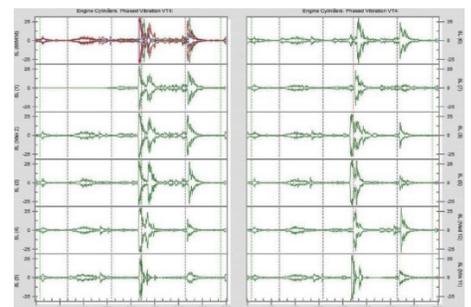
- The engine was severely out of range with respect to balance (255 psi spread)
- Peak firing pressure statistics vice exhaust temperatures did not point to specific cylinder timing issues
- All cylinders had over a 100 psi spread of peak pressure within 50 periods
- Spread of the peak pressure angle was not consistent and high (anywhere from 5 to 10 degrees)
- Phased vibration signatures were similar, not having consistently timed events
- Low frequency phased vibration was so severe that the accelerometer could not settle out

- Frame movement was higher than previous data
- Gear mesh frequency was so “noisy” that no particular number could be singled out

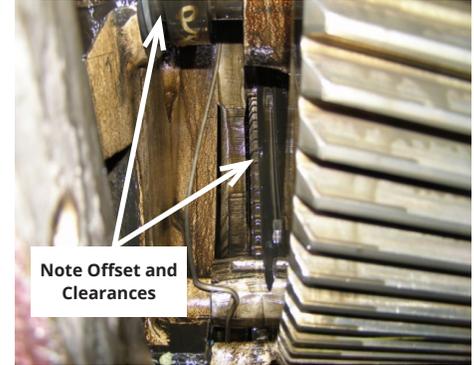
### Offset and clearances

The Fairbanks Morse analyst suspected there was a problem with the gearing and asked the Supervisor to shut the engine down and allow us to perform a visual inspection. All the helical gear teeth were found to have the usual wear patterns. However, during data collection we noticed a prominent yet inconsistent low frequency noise at the gear end. Review of the camshafts revealed the problem, one bank had thrust one-half inch away from the end support and the other was against it. We could also see the same amount of gap between the cam thrust face at the bearing. There was a similar misalignment between the gear faces.

The Fairbanks Morse analyst spoke to management and made the recommendation to stop use of the machine. Specifically, we stated they needed to disassemble the camshafts and inspect for further issues with the gear hubs and rectify the looseness of the thrust faces. Feedback from the customer revealed that the hubs had been incorrectly fit to the cams two years ago as there was 360 degree fretting, the keys and keyways were half sheared and the lock nuts were loose.
